# **DOWNEY AIRPORT (HYDE MEMORIAL)**

Using the branch, section and sample unit divisions established, a visual condition survey was conducted at Downey Airport (Hyde Memorial) on November 05, 2006. During the inspection pavement defects were identified and measured in accordance with the methodology outlined in FAA AC:150/5380-6 and ASTM D5430. Our inspection ensures your airport complies with the “detailed inspection” requirement of FAA’s PMMP guidelines. After collection, the data were entered into the Micro PAVER software for analysis. These data are reproduced in the Re-Inspection Report attached in Appendix 2. Photographs of typical distresses observed during the inspections are provided in Appendix 3.

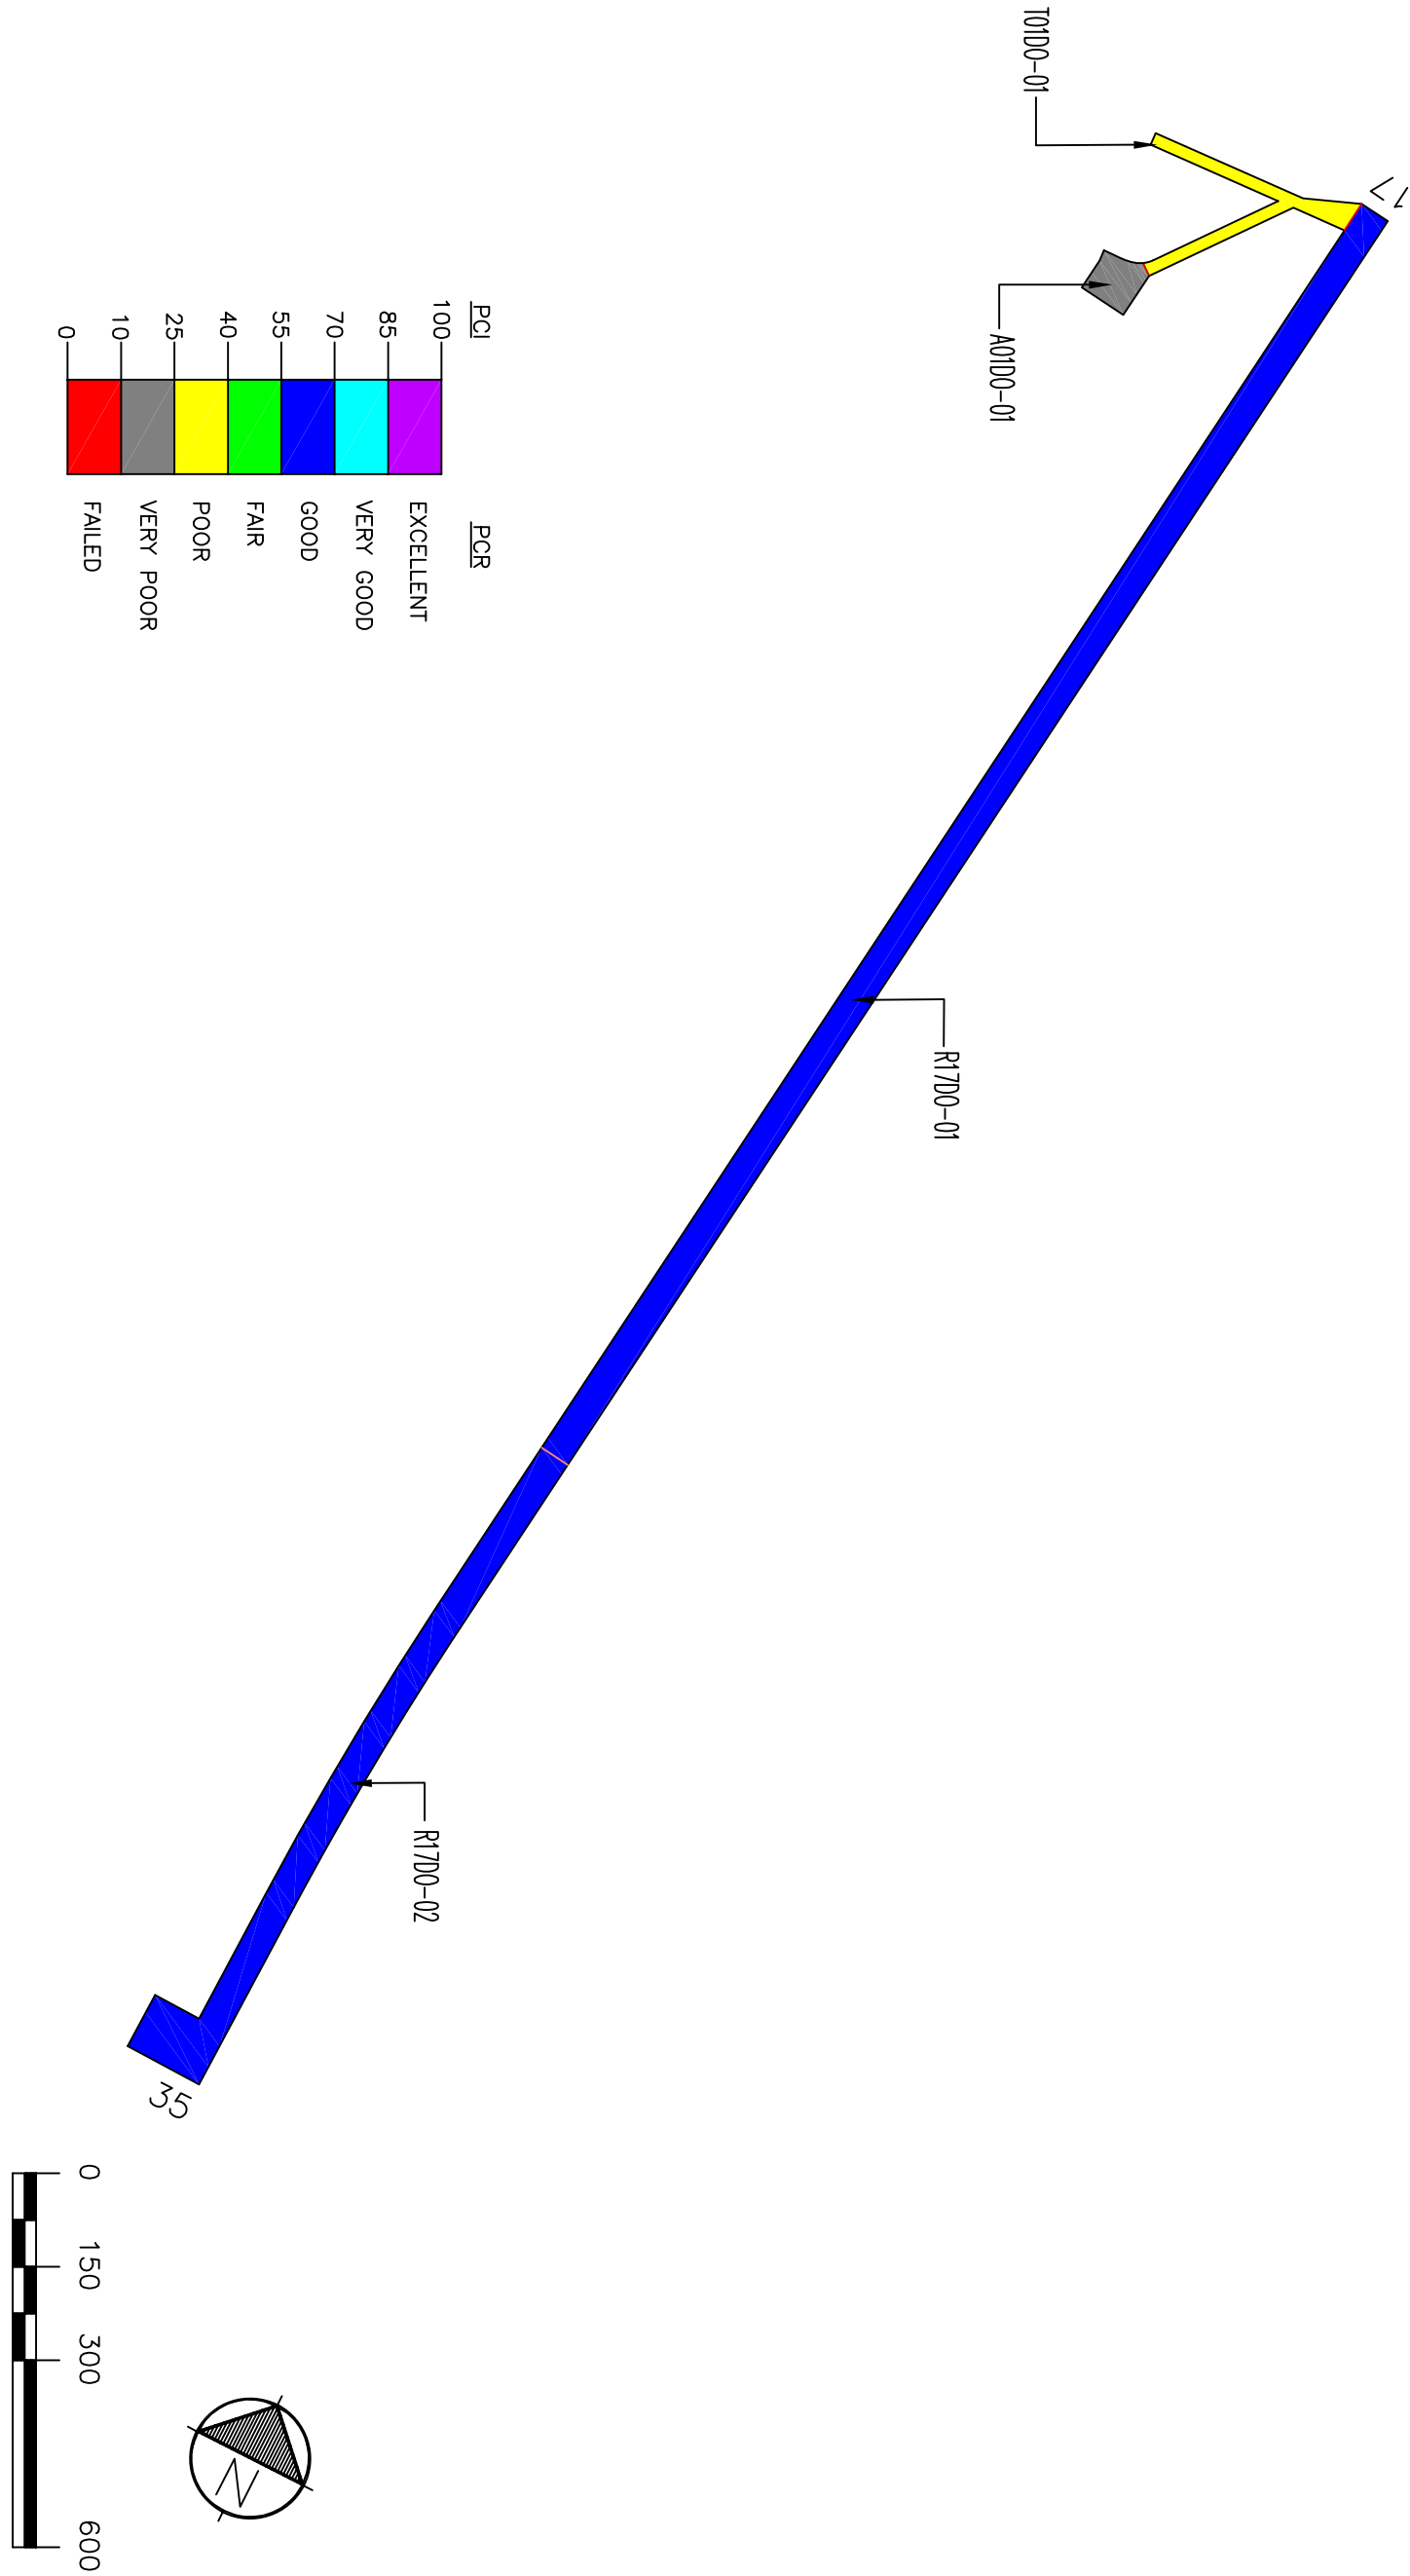
Figure D0-3. Pavement Condition in 2006.  
Downey Airport (Hyde Memorial)

Section PCIs at the airport range from a low of 18 (a PCR of “Very Poor”) to a high of 65 (a PCR of “Good”). The area-weighted average PCI for all airport pavements is 58, corresponding to an overall PCR of “Good”. Figure DO-4 shows how much pavement area is associated with each Pavement Condition Rating category and also shows pavement condition distribution from the inspections conducted in 1996 and 1999. A graphical representation of the projected PCRs presented in Table DO-2 is shown in Figure DO-5.

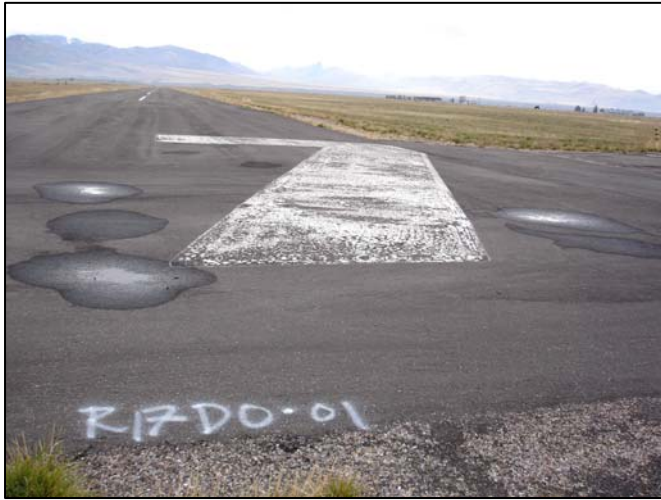
Sample Number:	01	Type:	R	Area:	5,000.00SqFt	PCI = 59
43	BLOCK CRACKING			L	4,999.96 SqFt	
53	RUTTING			L	100.00 SqFt	
Sample Number:	07	Type:	R	Area:	5,000.00SqFt	PCI = 59
43	BLOCK CRACKING			L	4,999.96 SqFt	
53	RUTTING			L	100.00 SqFt	
Sample Number:	13	Type:	R	Area:	5,000.00SqFt	PCI = 59
43	BLOCK CRACKING			L	4,999.96 SqFt	
53	RUTTING			L	100.00 SqFt	
Sample Number:	18	Type:	R	Area:	5,000.00SqFt	PCI = 59
43	BLOCK CRACKING			L	4,999.96 SqFt	
53	RUTTING			L	75.00 SqFt	
Sample Number:	24	Type:	R	Area:	4,500.00SqFt	PCI = 64
43	BLOCK CRACKING			L	4,499.96 SqFt

Section: R17DO-01  
Block Cracking

Year	Branch	Section	Action	Area (sf)	Unit Cost (\$/sf)	Total Cost (\$)
2007	A01DO	01	Reconstruct with 2" AC, 6" Gravel Base	6,186	\$2.14	\$13,238
	R17DO	01	2" AC Overlay	119,500	\$1.00	\$119,500
	R17DO	02	2" AC Overlay	65,450	\$1.00	\$65,450
	T01DO	01	Reconstruct with 2" AC, 6" Gravel Base	13,056	\$2.14	\$27,940
2007 Total						\$226,128
<b>TOTAL</b>						<b>\$226,128</b>

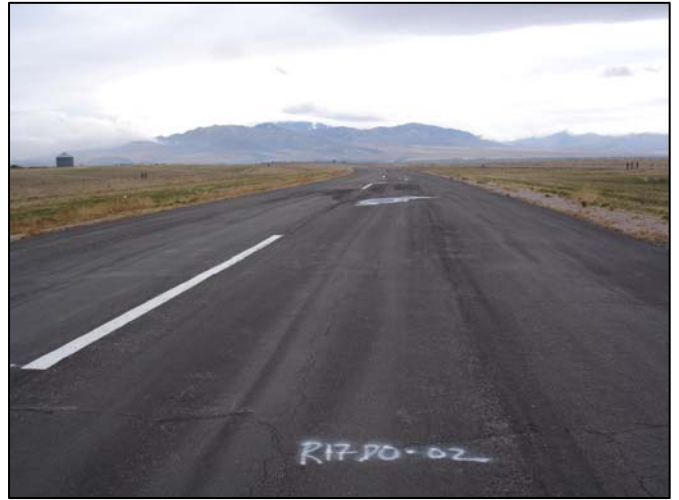
Sample Number: 02 Type: R Area: 5,000.00SqFt PCI = 52  
41 ALLIGATOR CRACKING L 300.00 SqFt  
48 LONGITUDINAL/TRANSVERSE CRACKING L 240.06 Ft  
53 RUTTING L 200.00 SqFt

Sample Number: 06 Type: R Area: 5,000.00SqFt PCI = 70  
43 BLOCK CRACKING L 1,599.99 SqFt  
48 LONGITUDINAL/TRANSVERSE CRACKING L 212.05 Ft

Sample Number: 10 Type: R Area: 5,000.00SqFt PCI = 67  
43 BLOCK CRACKING L 300.00 SqFt  
48 LONGITUDINAL/TRANSVERSE CRACKING L 709.18 Ft

Sample Number: 13 Type: R Area: 7,440.00SqFt PCI = 68  
43 BLOCK CRACKING L 3,023.97 SqFt  
48 LONGITUDINAL/TRANSVERSE CRACKING L 194.05 Ft

Section: R17DO-02  
Block Cracking,  
Longitudinal/ Transverse Cracking

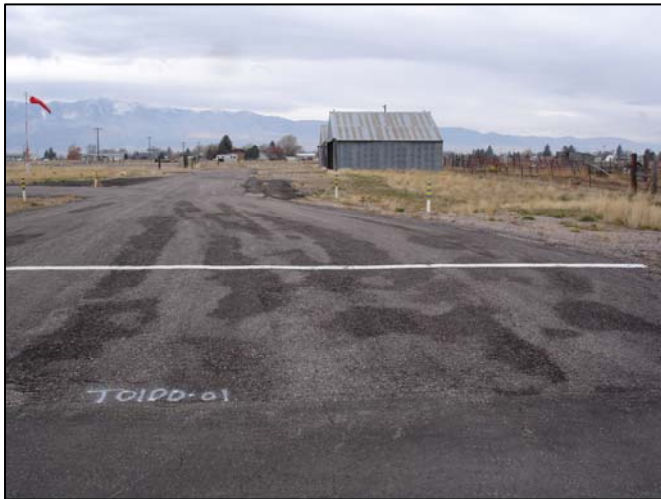
Sample Number:	01	Type:	R	Area:	4,095.00SqFt	PCI = 23
41	ALLIGATOR CRACKING		M	639.99	SqFt	
45	DEPRESSION		L	100.00	SqFt	
48	LONGITUDINAL/TRANSVERSE CRACKING		M	43.01	Ft	
52	WEATHERING/RAVELING		L	818.99	SqFt	
Sample Number:	02	Type:	R	Area:	4,000.00SqFt	PCI = 25
41	ALLIGATOR CRACKING		M	525.00	SqFt	
45	DEPRESSION		L	16.00	SqFt	
48	LONGITUDINAL/TRANSVERSE CRACKING		M	78.02	Ft	
52	WEATHERING/RAVELING		L	799.99	SqFt	
53	RUTTING		L	400.00	SqFt	
Sample Number:	03	Type:	R	Area:	4,961.00SqFt	PCI = 38
41	ALLIGATOR CRACKING		M	518.00	SqFt	
48	LONGITUDINAL/TRANSVERSE CRACKING		M	230.06	Ft

Section: T01DO-01  
Alligator Cracking  
Longitudinal/ Transverse Cracking  
Weathering/ Raveling

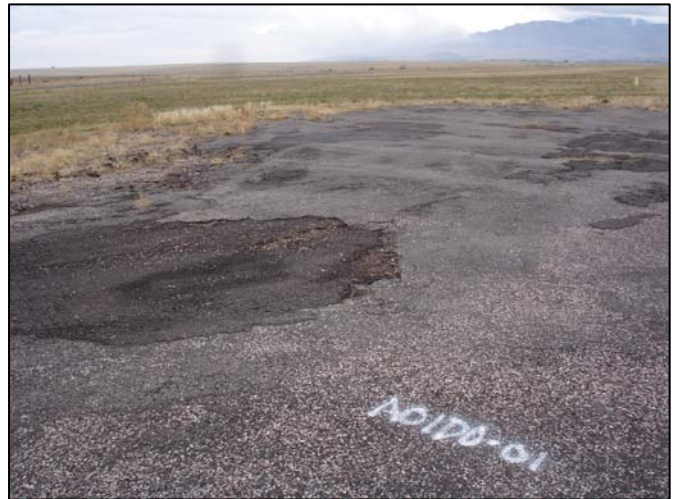
Sample Number:	01	Type:	R	Area:	6,186.00SqFt	PCI = 18
41	ALLIGATOR CRACKING	M		1,236.99	SqFt	
50	PATCHING	L		1,749.99	SqFt	
52	WEATHERING/RAVELING	L		1,854.98	SqFt	
52	WEATHERING/RAVELING	M		1,854.98	SqFt	
52	WEATHERING/RAVELING	H		50.00	SqFt	
45	DEPRESSION	L		115.00	SqFt

Section: A01DO-01  
Weathering/ Raveling  
Alligator Cracking  
Patching
